Engineering
UPDATE©

MEA MARINO ENGINEERING ASSOCIATES, INC. • Issue 1

SUCCESSFUL DEEP MINE BACKFILLING TO MITIGATE MINE SUBSIDENCE

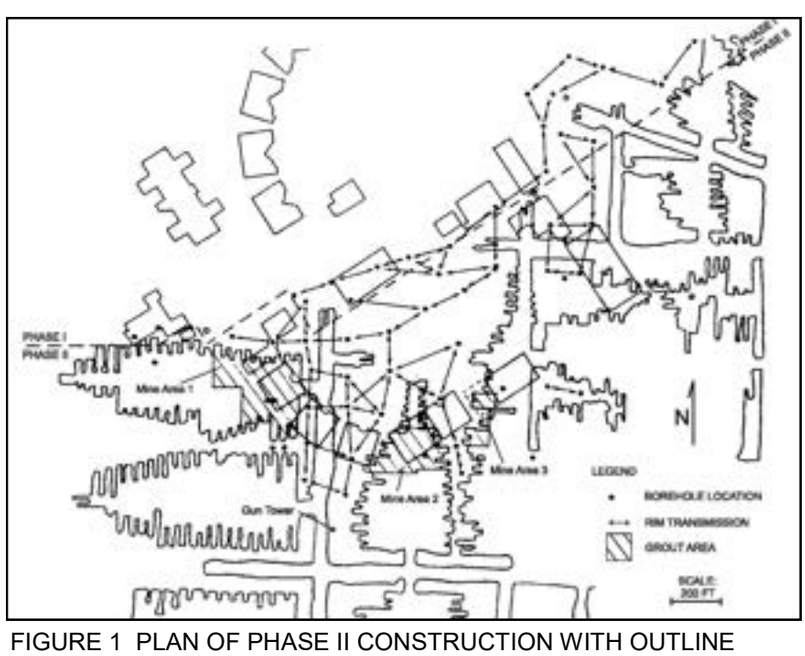
As shown in Figure 1, existing Phase I structures were just north of the Phase II construction. Contrary to Phase I, many of the Phase II structures were undermined. Therefore, because of the approximately 300 ft. deep abandoned mine void, there was a significant potential for mine subsidence that could result at a number of the proposed Phase II structures. History shows that a structure ill prepared to handle mine subsidence performs very poorly with the associated damage resulting in abandonment of the structure. In order to limit the possible subsidence damage and to ensure safe operation of the structures, mine backfilling was performed in mine areas labeled Mine Areas 1, 2, and 3 which were subjacent to critical Phase II structures (see Figure 1).

FIGURE 1 PLAN OF PHASE II CONSTRUCTION WITH OUTLINE OF MINING AND MINE AREAS THAT WERE GROUTED

contained more roof cave than Mine Area 2. Mine Area 3 appeared to have the most fall. This area, however, was small in comparison with the other two areas. The effect of the additional amount of rubble in the mine seemed nominal, as there was no substantial change in the grouting operation from Mine Areas 1, 2, and 3.

During the grouting operation, each mine area was first contained by strategically placing containment grout in certain entries and crosscuts. Once the mine areas were significantly contained, they were pumped with infill grout (which was lower in cost and more flowable than containment grout). Infill grouting generally proceeded across the mine with each injection hole grouted to refusal. In some highly rubblized areas, some retarder/plasticizer (calcium lignosulfonate) was used in the grout to increase penetration.

At the completion, 9,559 cy of cement-flyash-sand grout was injected and 41,349 LF of drilling was performed. By implementing this backfill procedure, the potential subsidence at certain Phase II structures was suppressed at the prison site at Carlisle, Indiana. The backfilling was found to be significantly more cost-effective than designing each structure to be subsidence resistant.

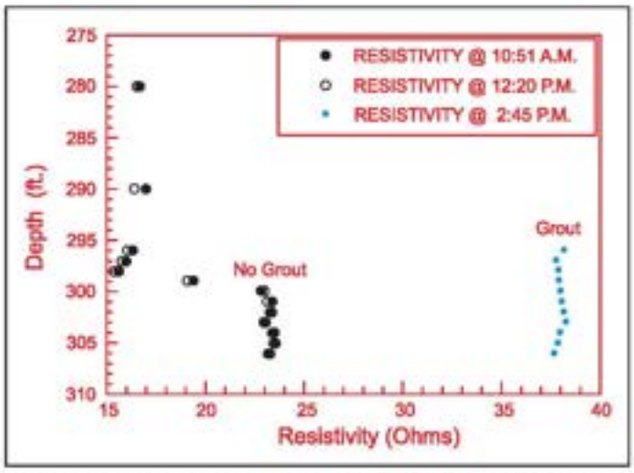
FIGURE 2 RESISTIVITY PROFILE USING ELECTRICAL PROBE (RESISTIVITY PROBE)

Once the grout operation began, the grout movement was monitored in adjacent holes by using electric resistivity probes (see Figure 2). Most of the holes were pumped to refusal. Refusal could not be achieved by only working the day shift despite pumping grout at typically 30-40 cy/hr., and so multiple shifts were necessary. Grout line refusal was taken at 600 psi or greater.
